EVIDENTIARY IMAGING SUBSYSTEM

EVIDENTIARY IMAGE RECEIVING &
AUTHENTICATION SUBSYSTEM

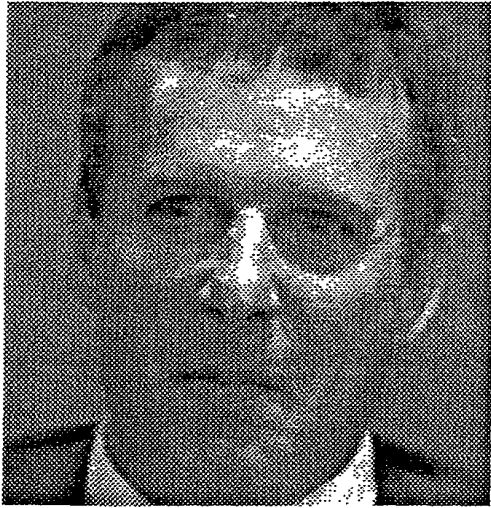
FIGURE 5a

CAPTURED IMAGE

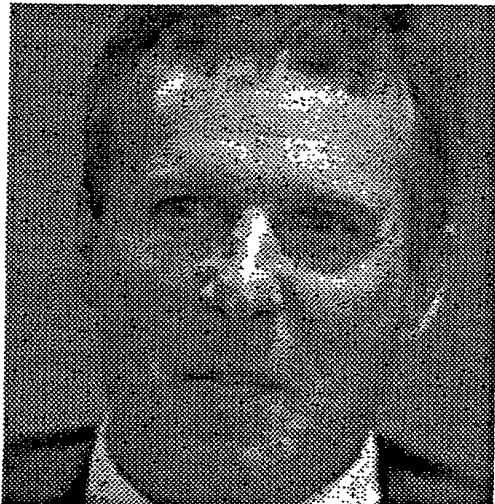
FIGURE 5c

ENCODING + IMAGE
